Contract #: 04-0120F4Cty: SF/ALA Rte: 80 PM: 13.2/13.9File #: 69.28**WELDING INSPECTION REPORT****Resident Engineer:**Pursell, Gary**Address:** 333 Burma Road**City:** Oakland, CA 94607**Report No:** WIR-010644**Date Inspected:** 03-Dec-2009**Project Name:** SAS Superstructure**OSM Arrival Time:** 1900**Prime Contractor:** American Bridge/Fluor Enterprises, a JV**OSM Departure Time:** 700**Contractor:** Zhenhua Port Machinery Company, Ltd (ZPMC), Changxing Island **Location:** Shanghai, China**CWI Name:** Tu Jun**CWI Present:** Yes No**Inspected CWI report:** Yes No N/A**Rod Oven in Use:** Yes No N/A**Electrode to specification:** Yes No N/A**Weld Procedures Followed:** Yes No N/A**Qualified Welders:** Yes No N/A**Verified Joint Fit-up:** Yes No N/A**Approved Drawings:** Yes No N/A**Approved WPS:** Yes No N/A**Delayed / Cancelled:** Yes No N/A**Bridge No:** 34-0006**Component:** OBG/TOWER**Summary of Items Observed:**

WELDING INSPECTION REPORT

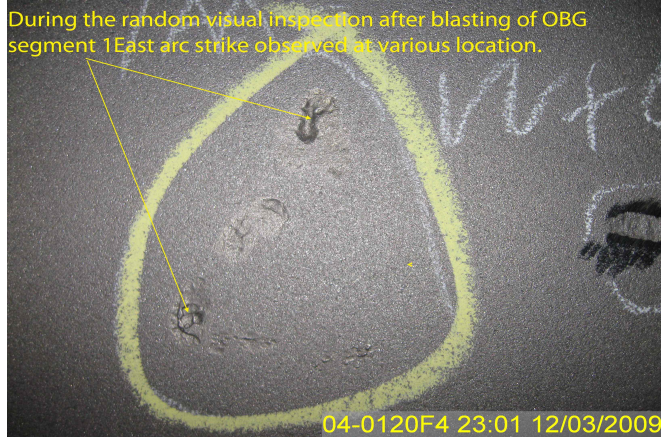
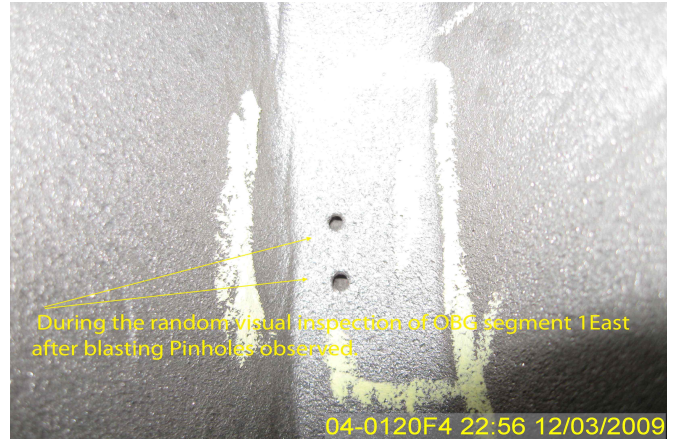
This Quality Assurance (QA) inspector performed random visual inspection after blasting along with Caltrans Quality Assurance (QA) Inspector Mr. Paul Dawson on the re-blasted area of side panel from panel point 8.5 to panel point 9, bottom panel splice weld between OBG segment 1AAE and 1AE and the starting portion of segment 1East adjacent to bottom panel from inside only. During the inspection we found normal minor gouges, arc strikes, pinhole, undercut. ZPMC Inspection request number was 2110. See attached photos for additional information.
